# SERVICE BULLETIN

**Date:** April 6, 2015  
**Update Number:** S2015-11  
**Subject:** Wrong Output Plug  
**Products Affected:** 85LM Transformer

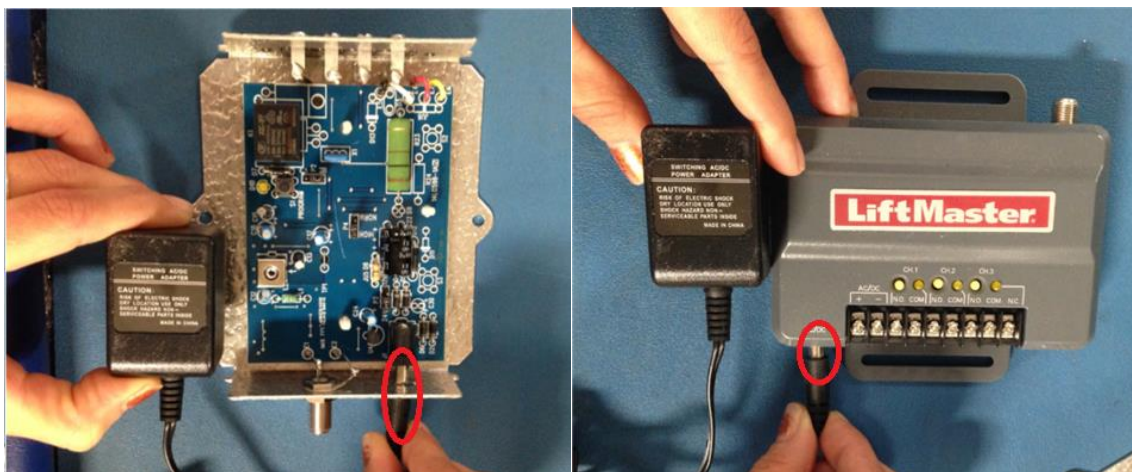
## 85LM TRANSFORMER

Recently, there have been several field reports that a small quantity of 85LM Universal Radio Control Plug-In AC Transformers have been released with an output plug that is too small to plug into the intended LiftMaster products. Only a small quantity of 85LM Transformers produced on February 6, 2015, are affected.

If you experience this issue, please contact LiftMaster Technical Support at 800.528.2806 to obtain a Return Goods Authorization for a replacement.
